INSPECTION REPORT

Report No.: MIL G2NG-5-0001-01

| Inspection | SMLS Pipes | | | |
| Specification: | API 5L 44 <sup>th</sup> Edition Gr.B /<br>ASTM A106 Gr. B | Inspector: | Lin<br>Gaojie | Stamp No: |

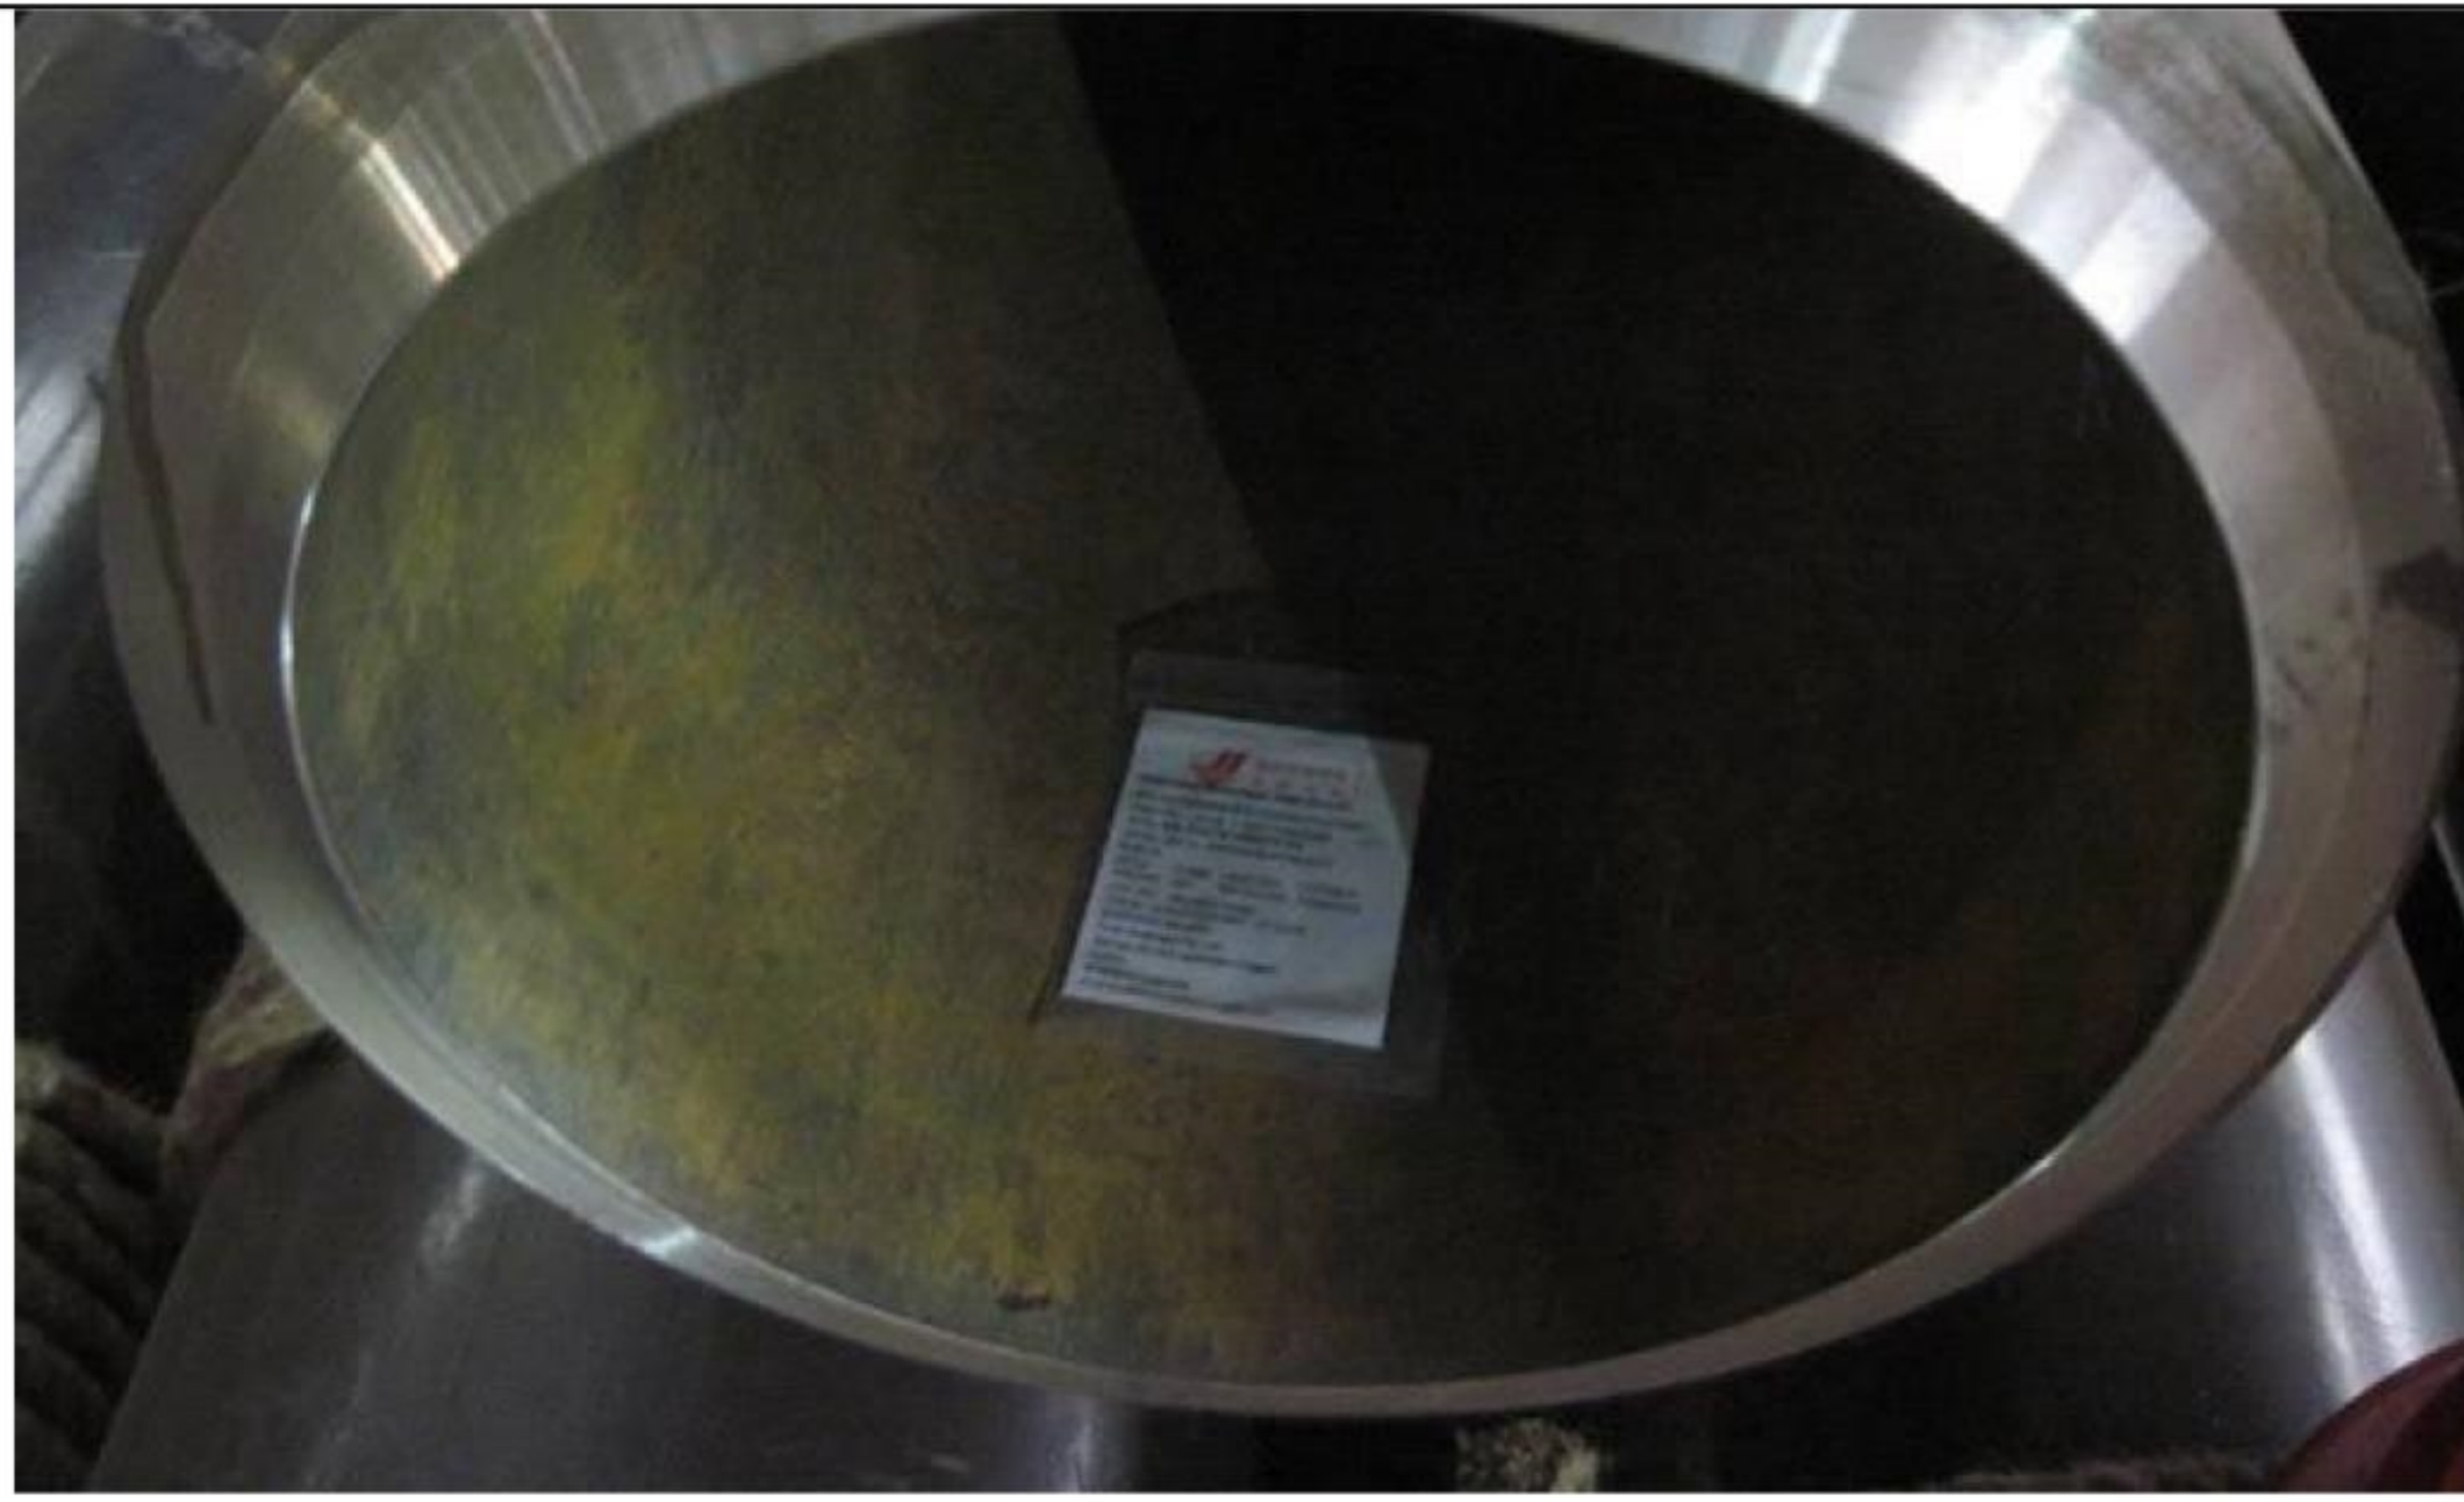
Bevel end in accordance with ASME B16.25, fig.

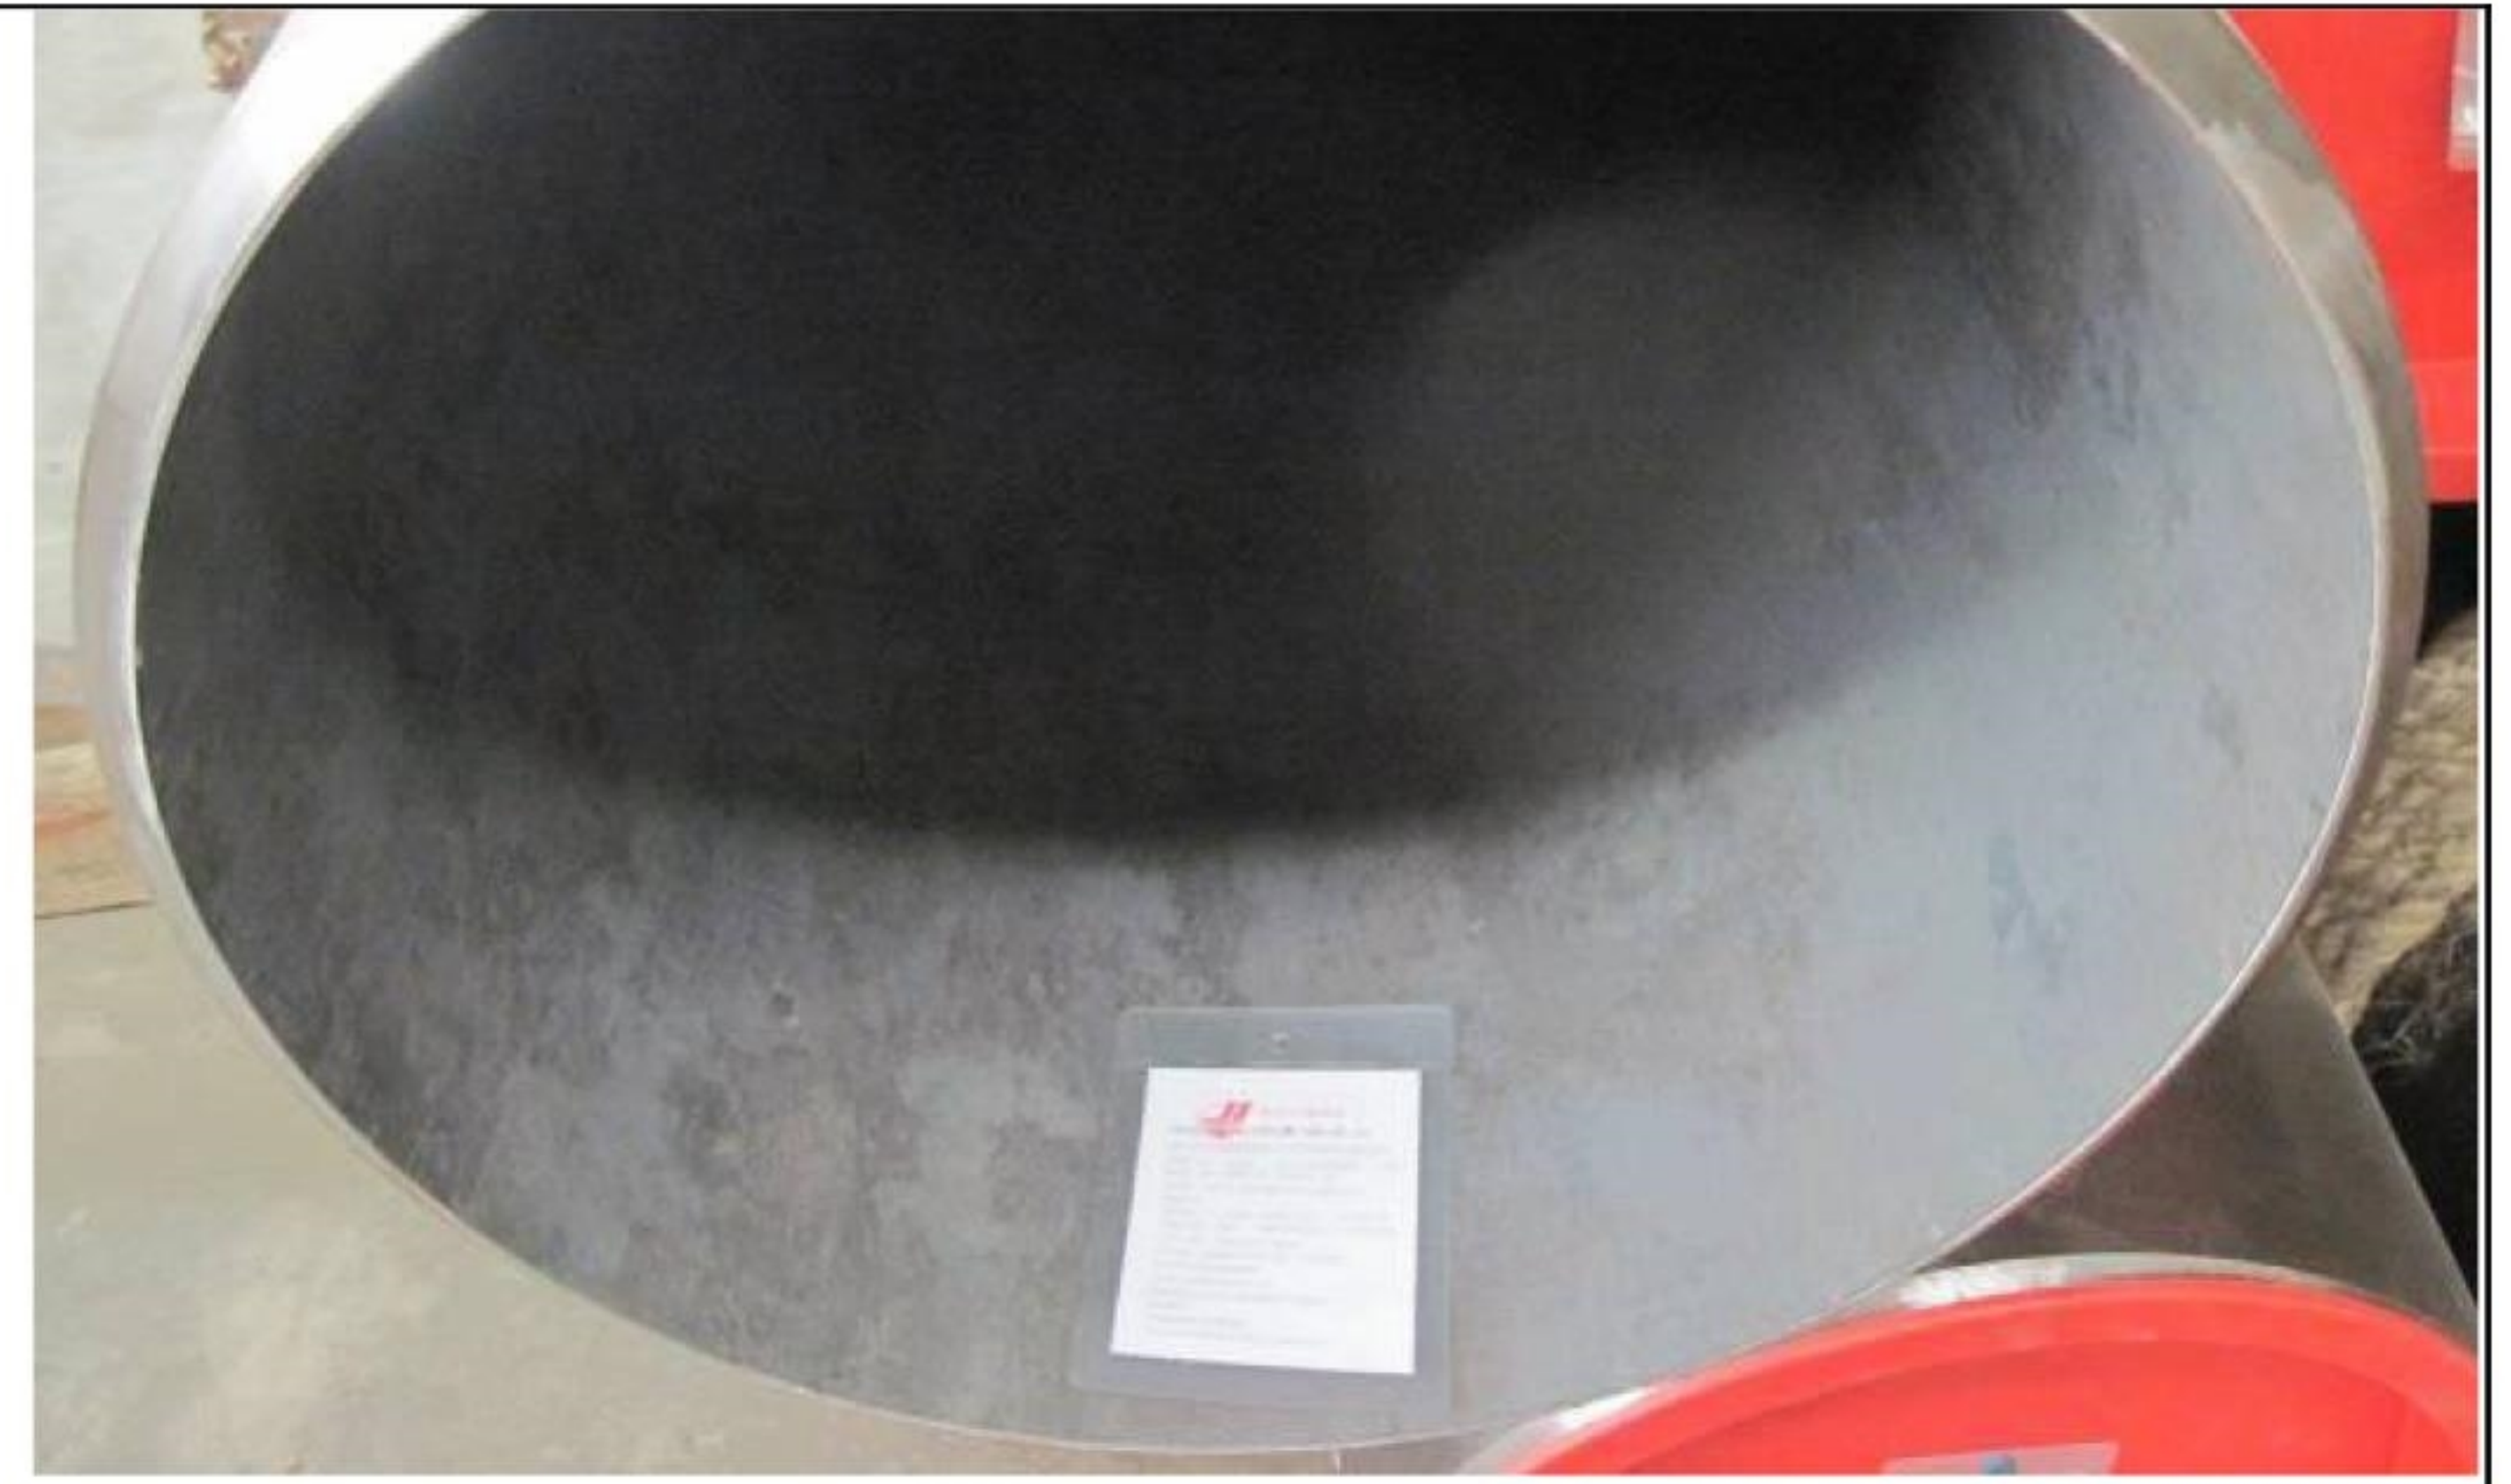
Bevel end in accordance with ASME B16.25, fig.

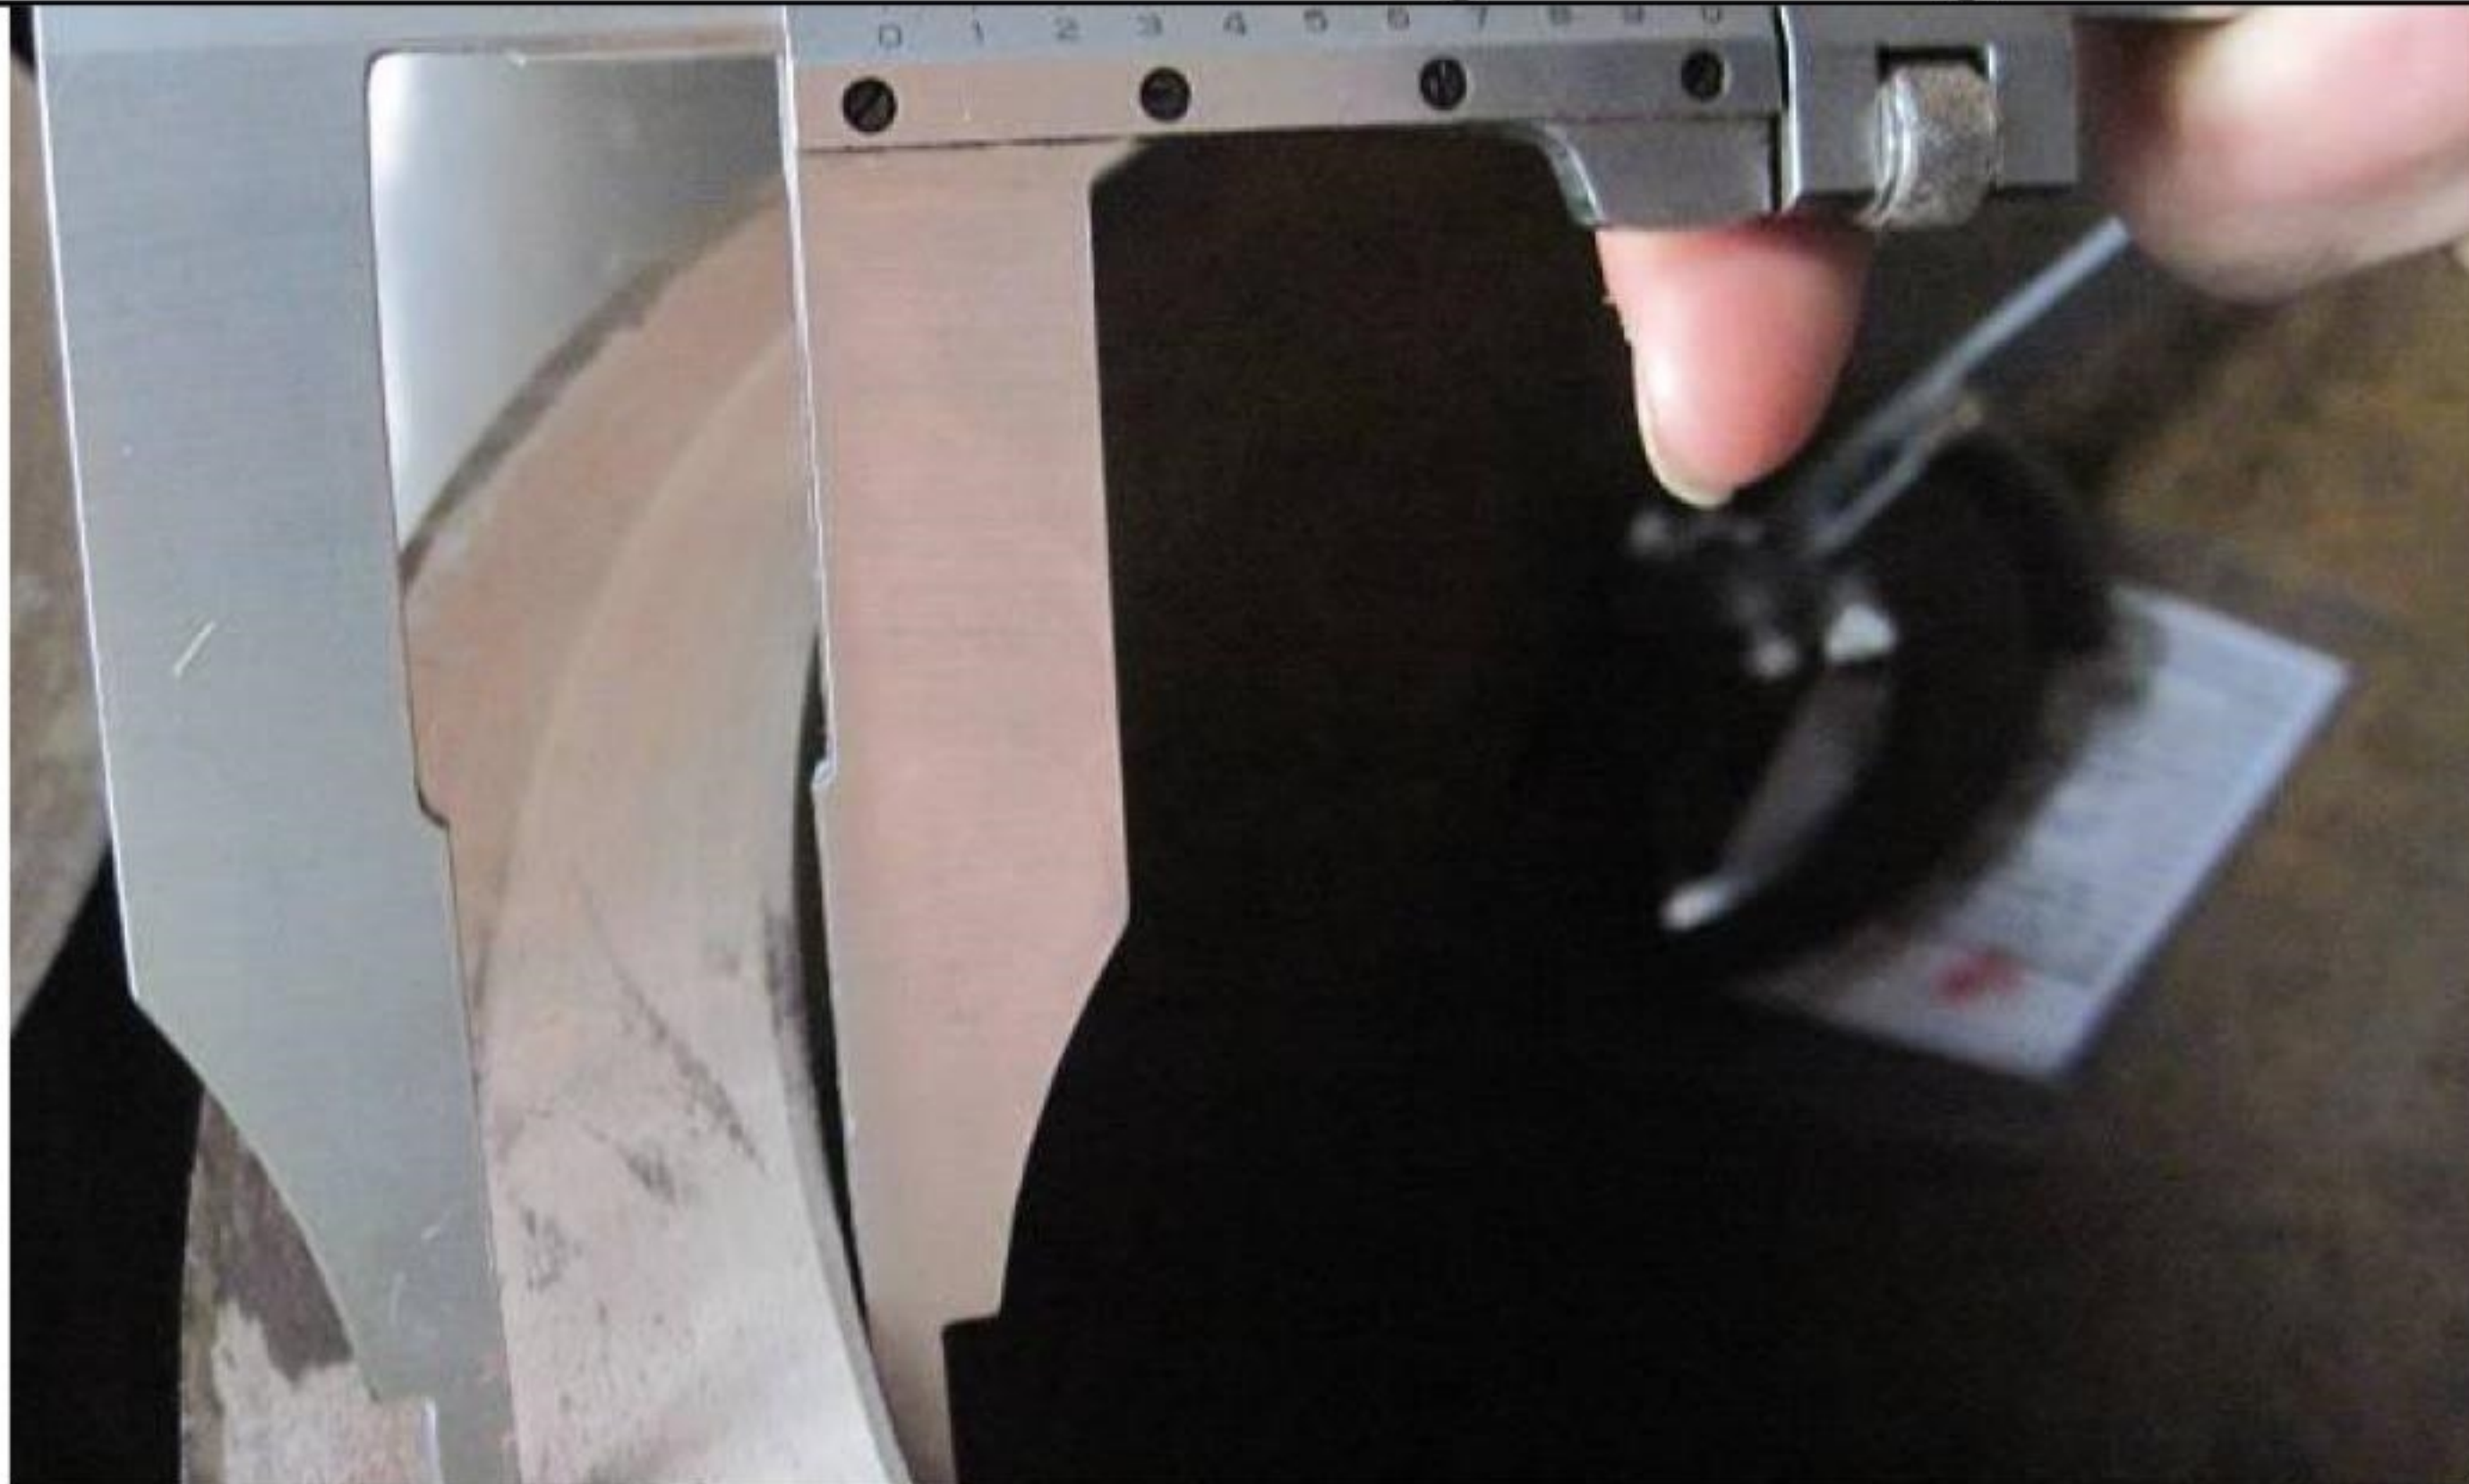
Measuring bevel angle in accordance with ASME B16.25, fig. 3a

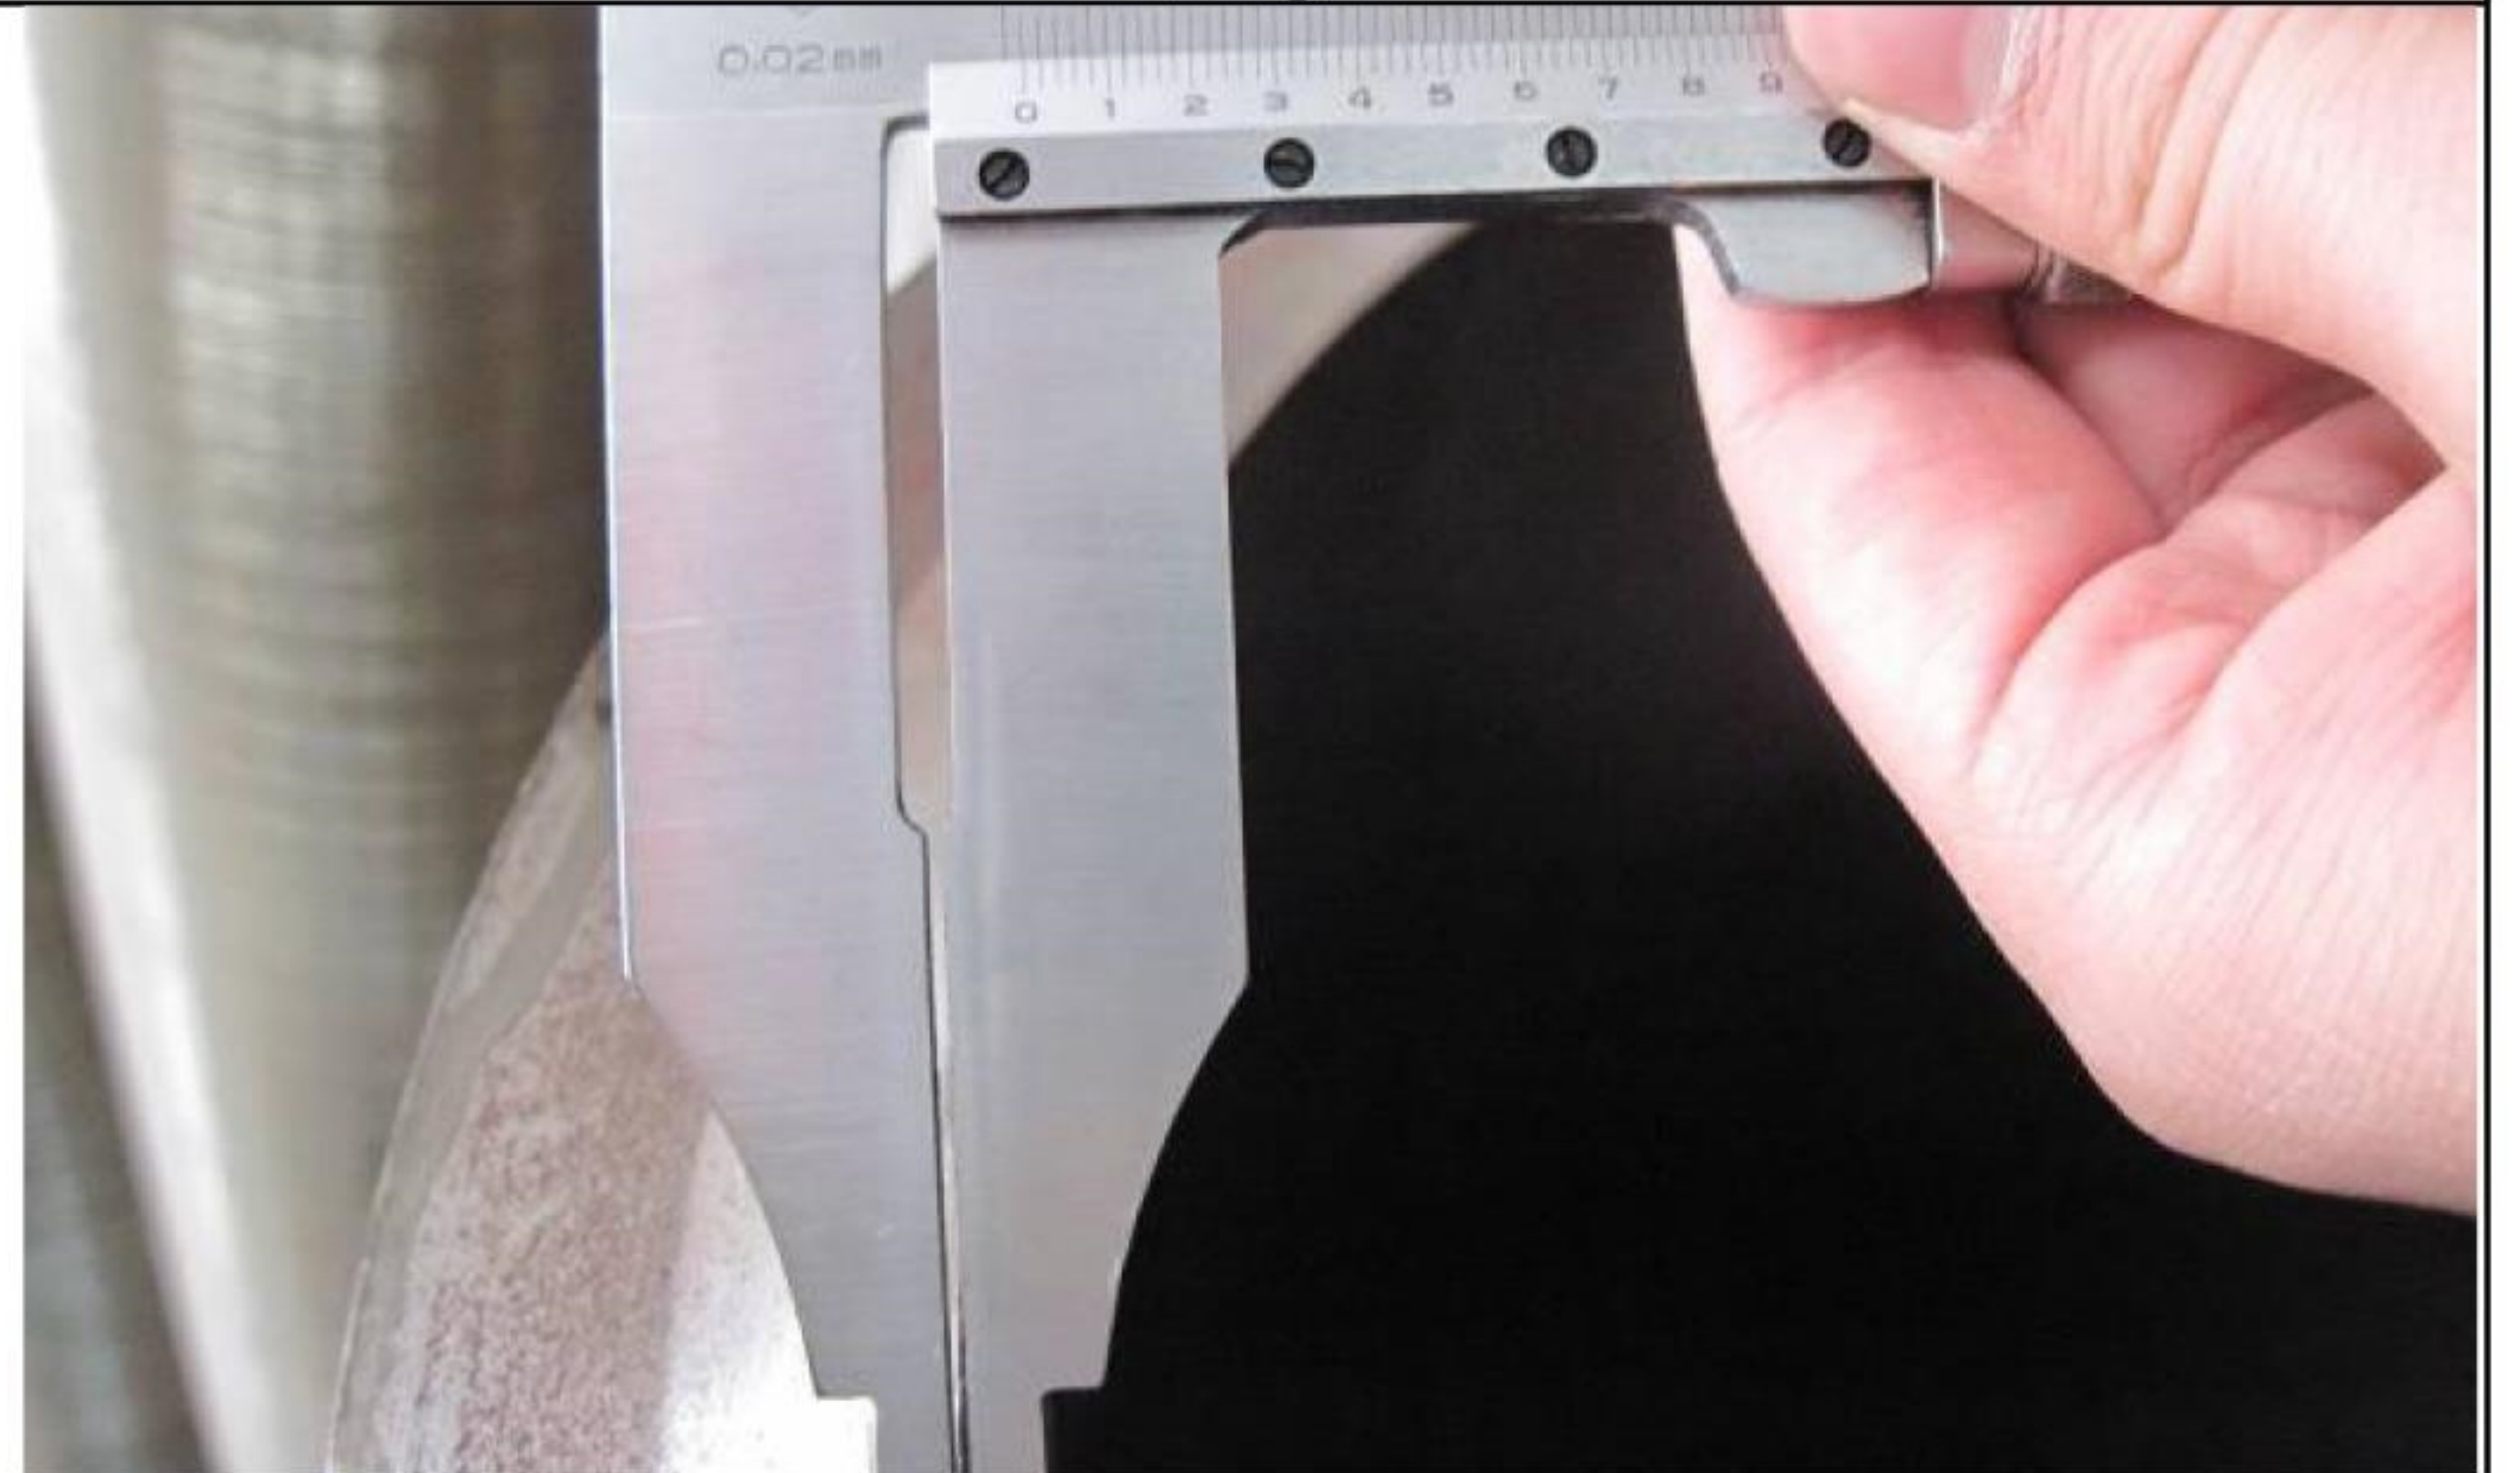
Measuring height of bevel angle and root face in accordance with ASME B16.25, fig. 3a
